INVESTIGATION OF THE VULNERABILITY TO
BALLISTIC ATTACK OF TWO T77 OSCILLATING TURRETS (U)
FIFTY-THIRD REPORT ON ORDNANCE PROJECT NO. TTL-5
DATES OF TEST: 10 FEBRUARY 1956 - 18 SEPTEMBER 1956

To evaluate the protection afforded against ballistic attack by two T77 oscillating turret body castings.

INVESTIGATION OF THE VULNERABILITY TO
BALLISTIC ATTACK OF TWO T77 OSCILLATING TURRETS (U)

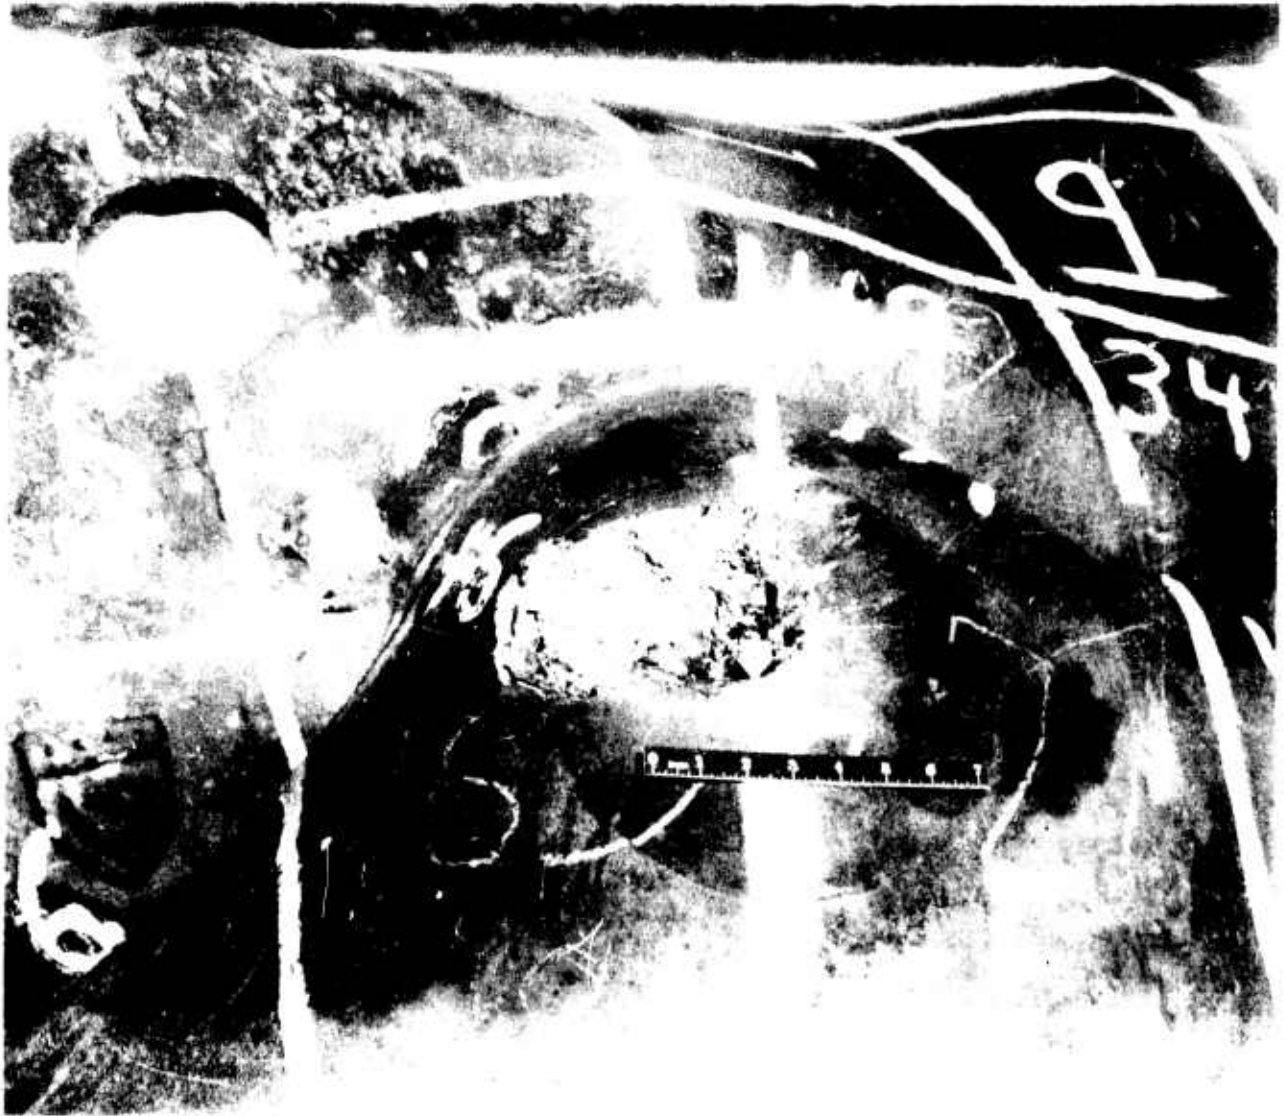
B18259: View of trunnion bearing cap on right side showing external damage after being attacked with a 90mm APT33 Projectile at a striking velocity of 2007 fps. Turret immobilized by impact.

6. Both of the trunnion bearings were subjected to a 90° flank attack, measured 90° off the longitudinal axis of the turret, with the 90mm AP T33 projectile. The right trunnion cap was impacted at a striking velocity of 2007 fps. The turret was immobilized with no apparent damage on the interior. The left trunnion was impacted at a striking velocity of 2004 fps. An oil leak around the trunnion hub on the interior was noted. The turret was immobilized by this impact. Photograph B18291 depicts typical damage to the bearings as a result of these impacts.

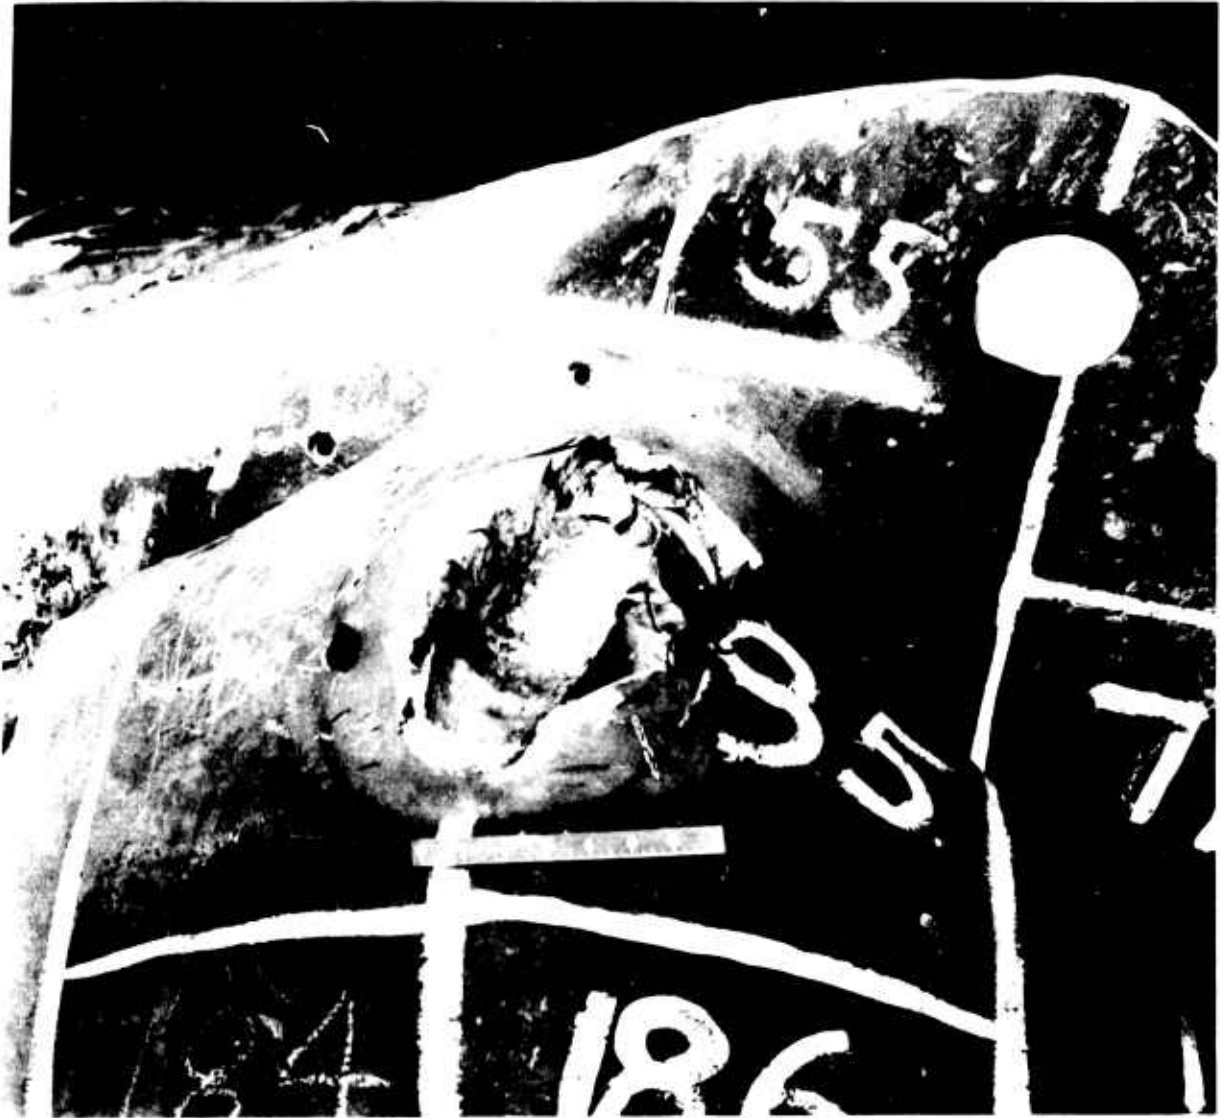
B18260: View of trunnion bearing cap on left side showing external damage after being attacked with a 90mm APT33 Projectile at a striking velocity of 2004 fps. Turret immobilized by impact.

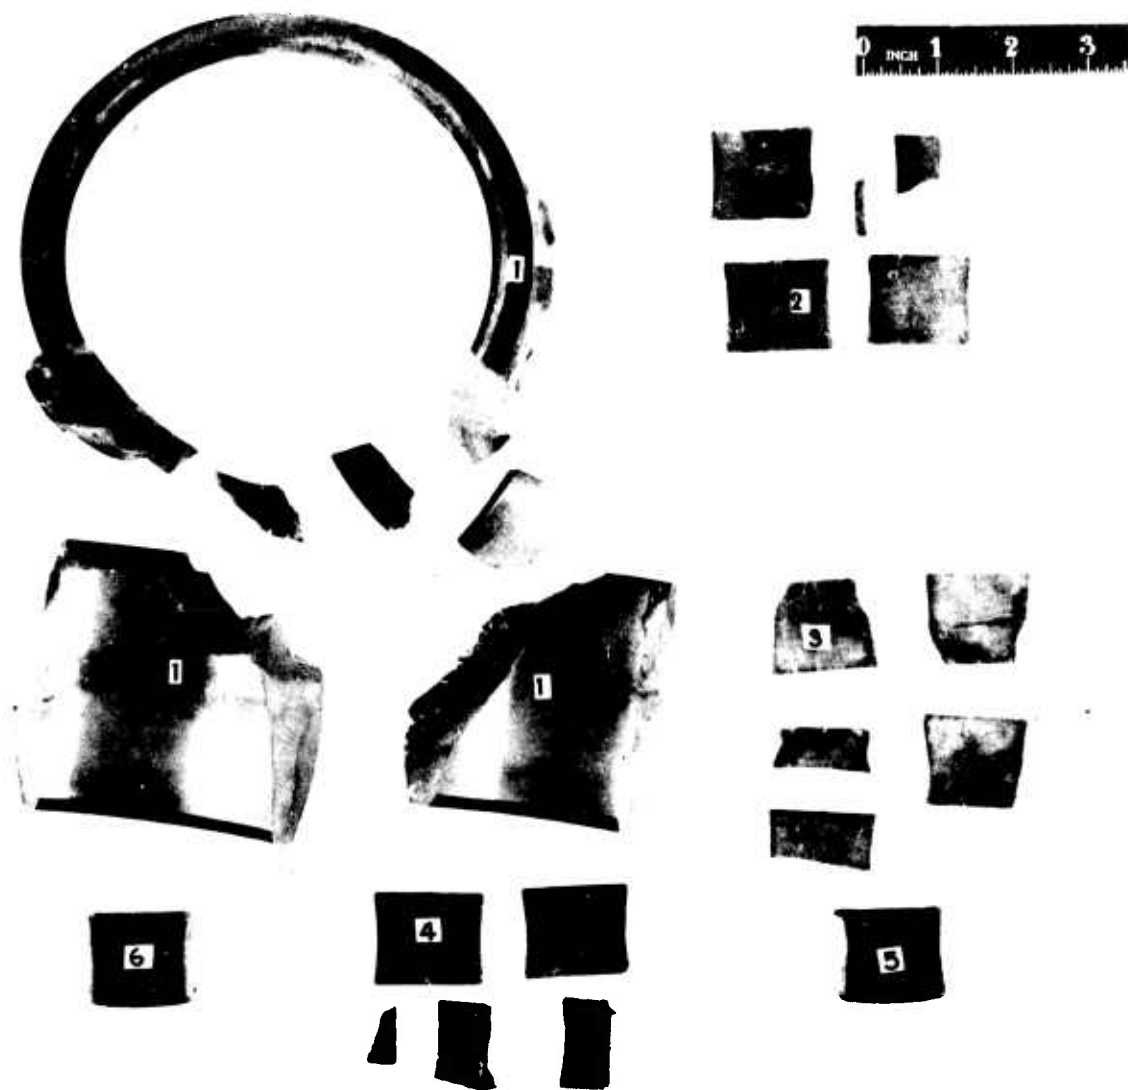
B18291: Photograph of interior damage to the left trunnion bearing after being impacted with one 90mm, AP, T33E7 Projectile at 2000 fps level. (1) Bearing race ring shattered on impact, (2-3-4) roller bearings shattered on impact, (5-6) roller bearing deformed on impact.

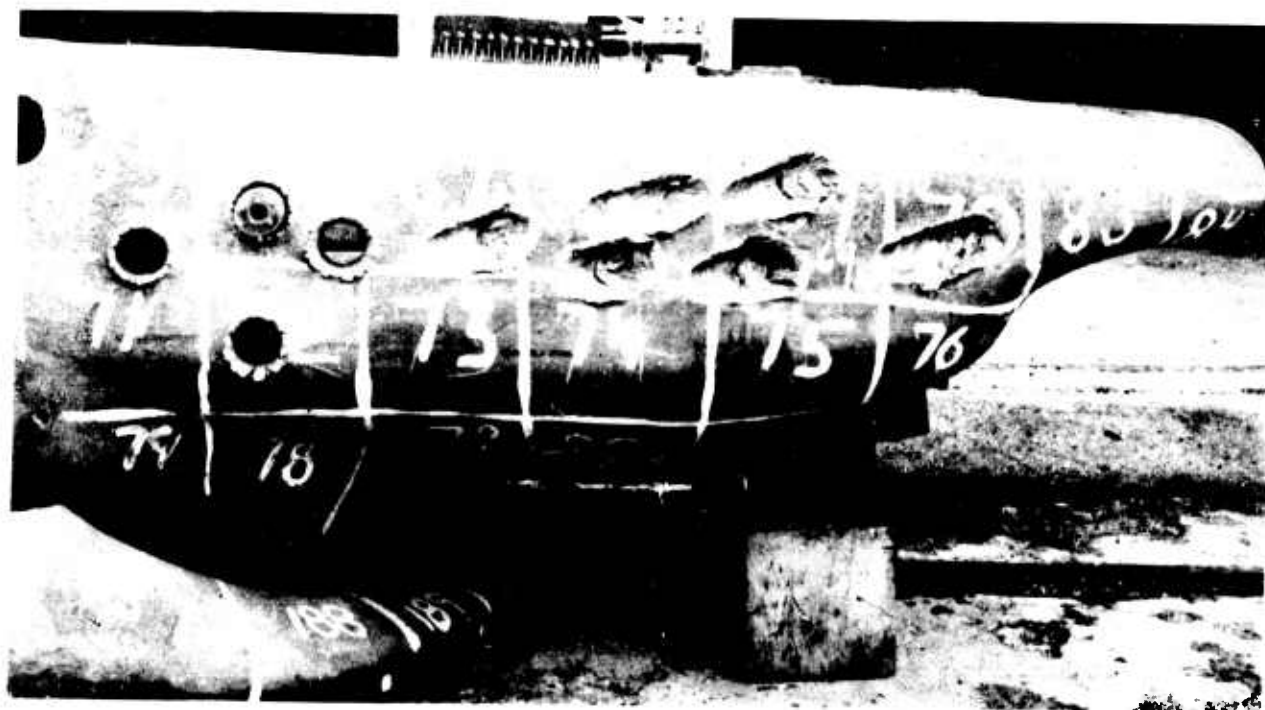
B18538: Outside view of the left side of the turret (front) showing impact damage of ten 76mm AP T128E6 projectiles. Four 76mm AP projectiles were fired at 0° obliquity in sections 65, 66, 71 and 72. Hole in the lower right corner of section 66 was caused by a disregarded round. Six 76mm AP projectiles were fired at 60° obliquity in section 67, 68, 69, 70, 74 and 75.

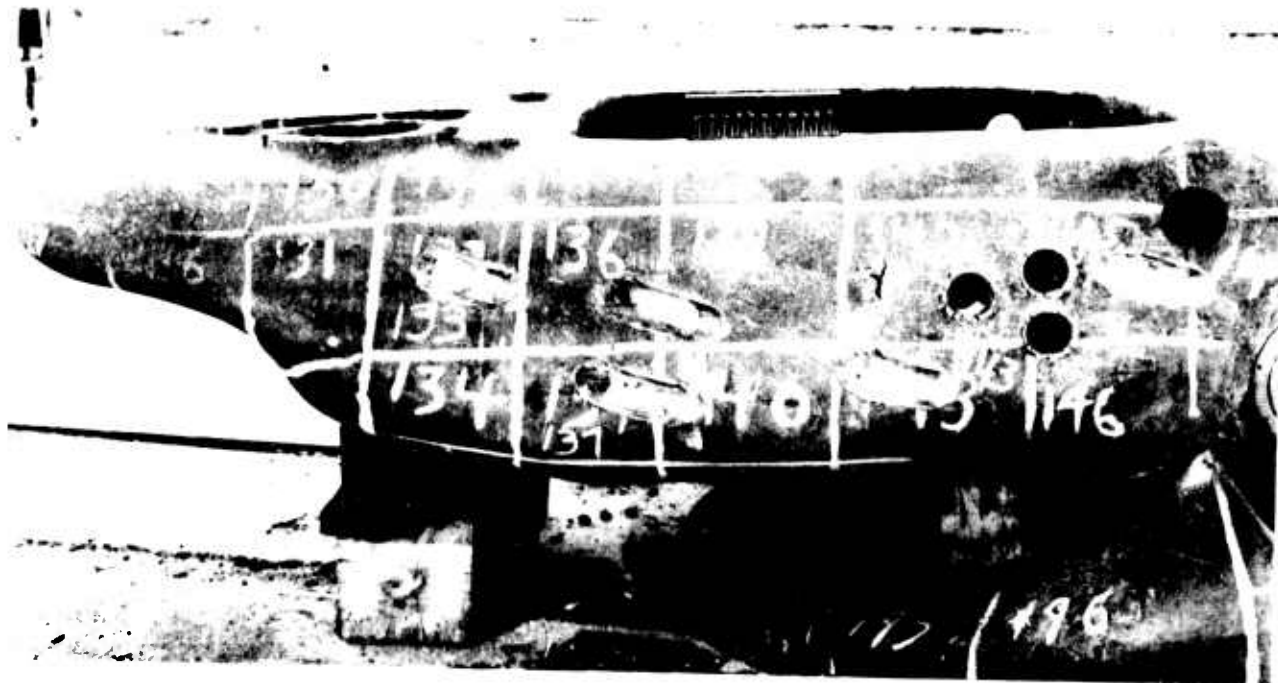
B18539: Outside view of the right side of the turret (front) showing impact damage of eight 76mm AP T128E6 projectiles. Three 76mm AP projectiles were fired at 0° obliquity in sections 142, 145 and 146. Five 76mm AP projectiles were fired at 60° obliquity in sections 133, 136, 137, 139, 140, 143, 145 and 148.

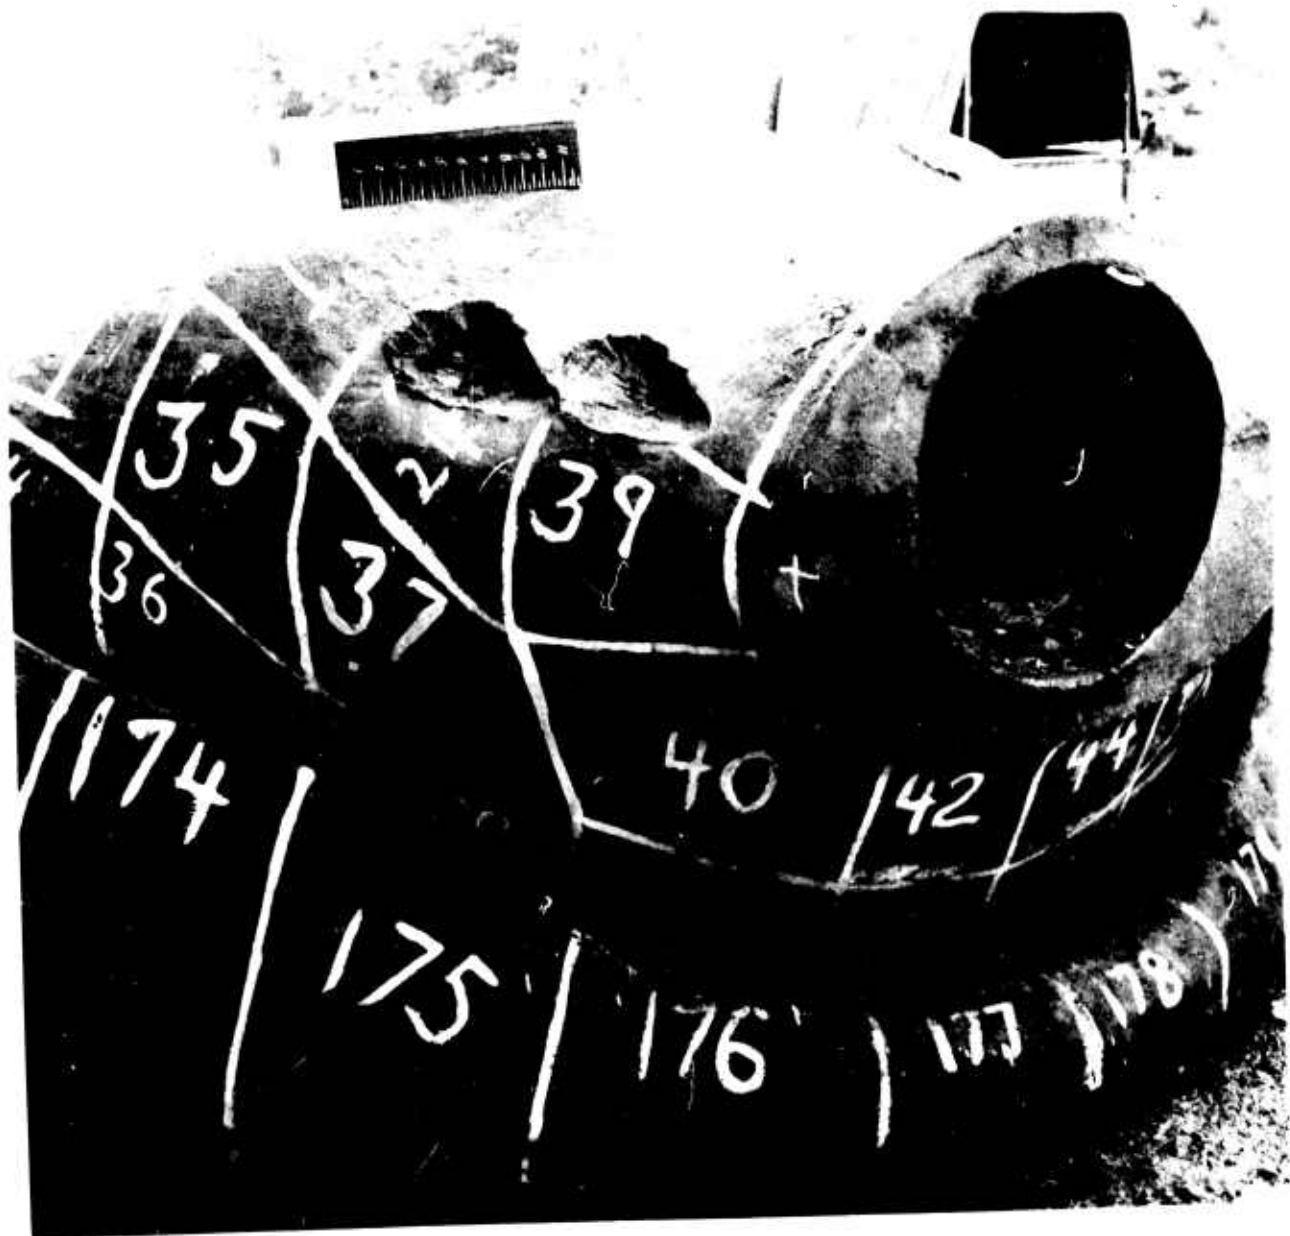
B18542: Effect of two 90mm AP, T33 projectile impacts from direct front against the right side of the turret. Exterior view.

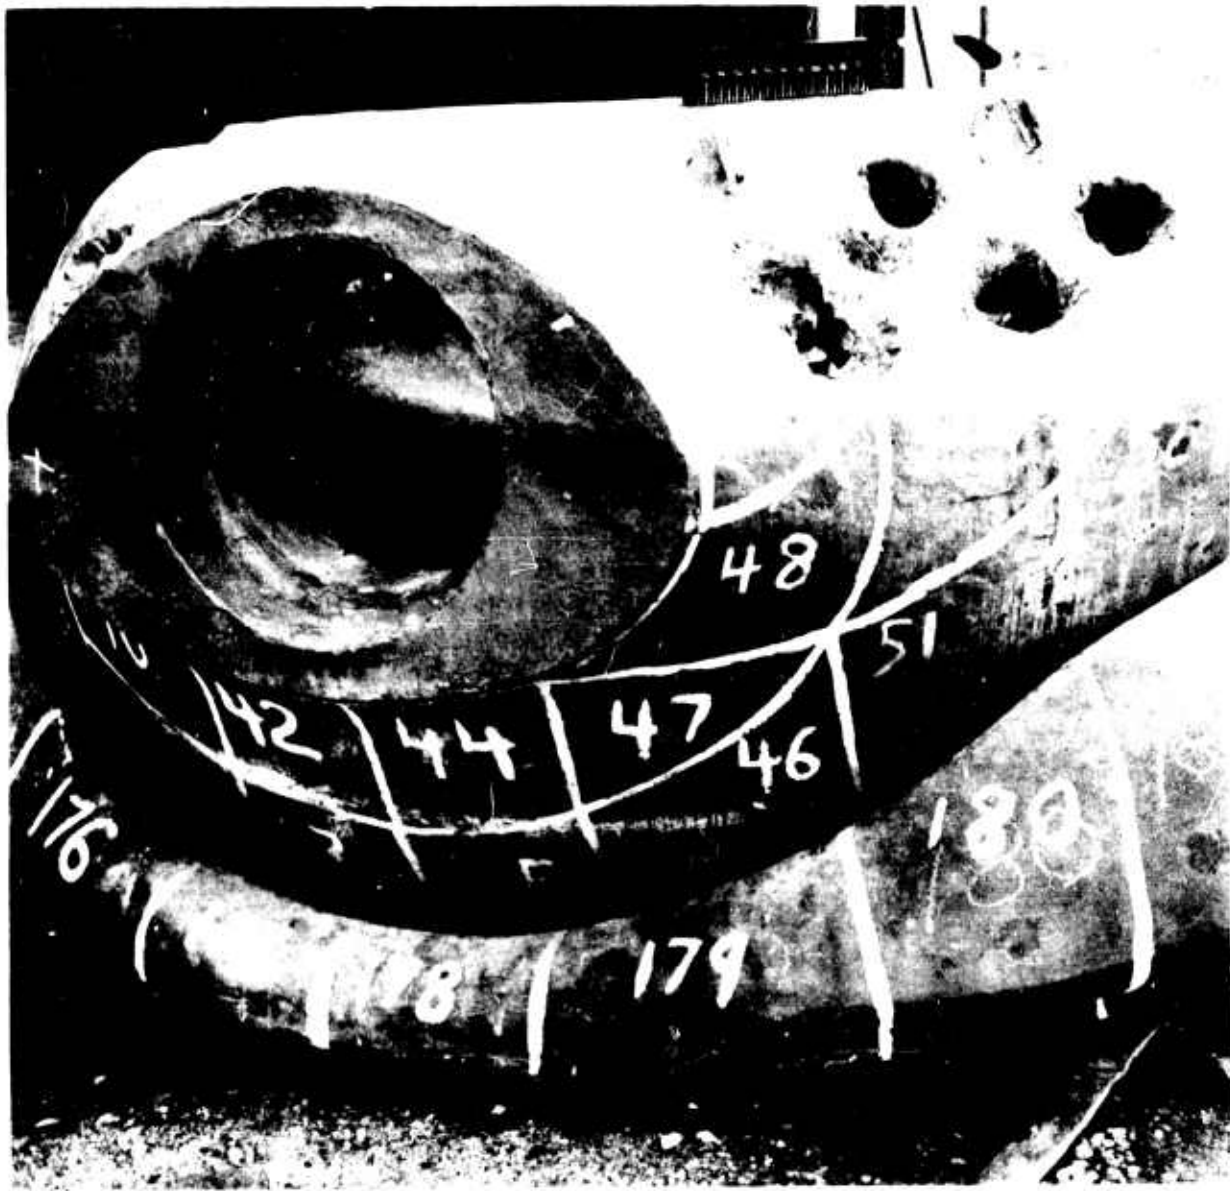
B18543: Effect of eight 90mm AP T33 projectile impacts from a 30° flank against the left side of the turret. Exterior view.

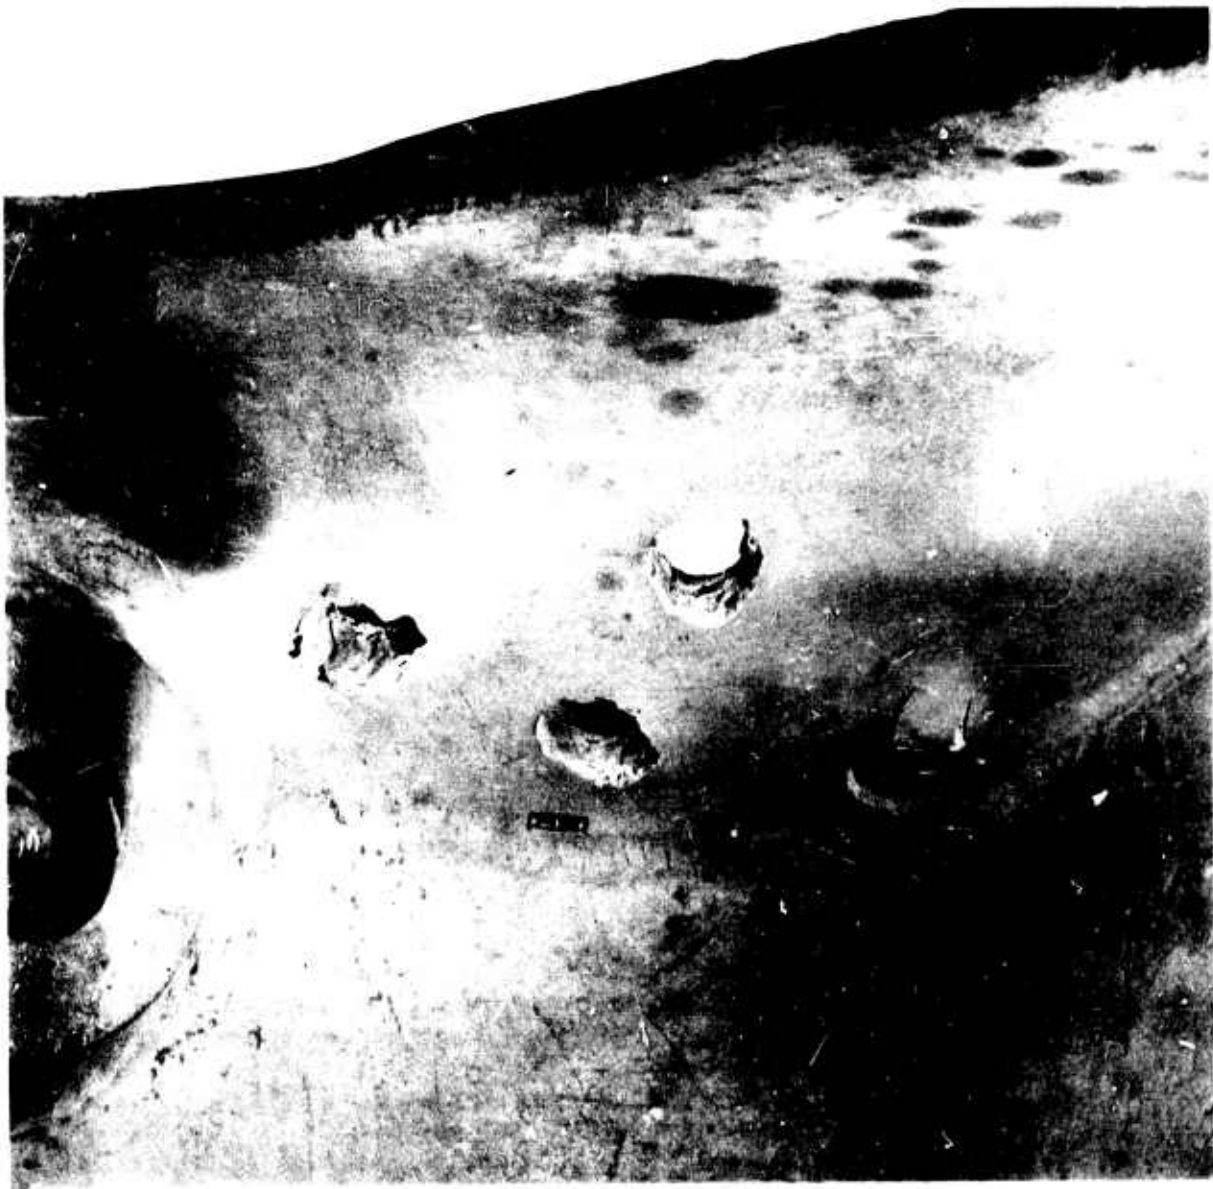
B18544: Effect of eight 90mm AP T33 projectile impacts from a 30° flank against the left side of the turret. Interior view.

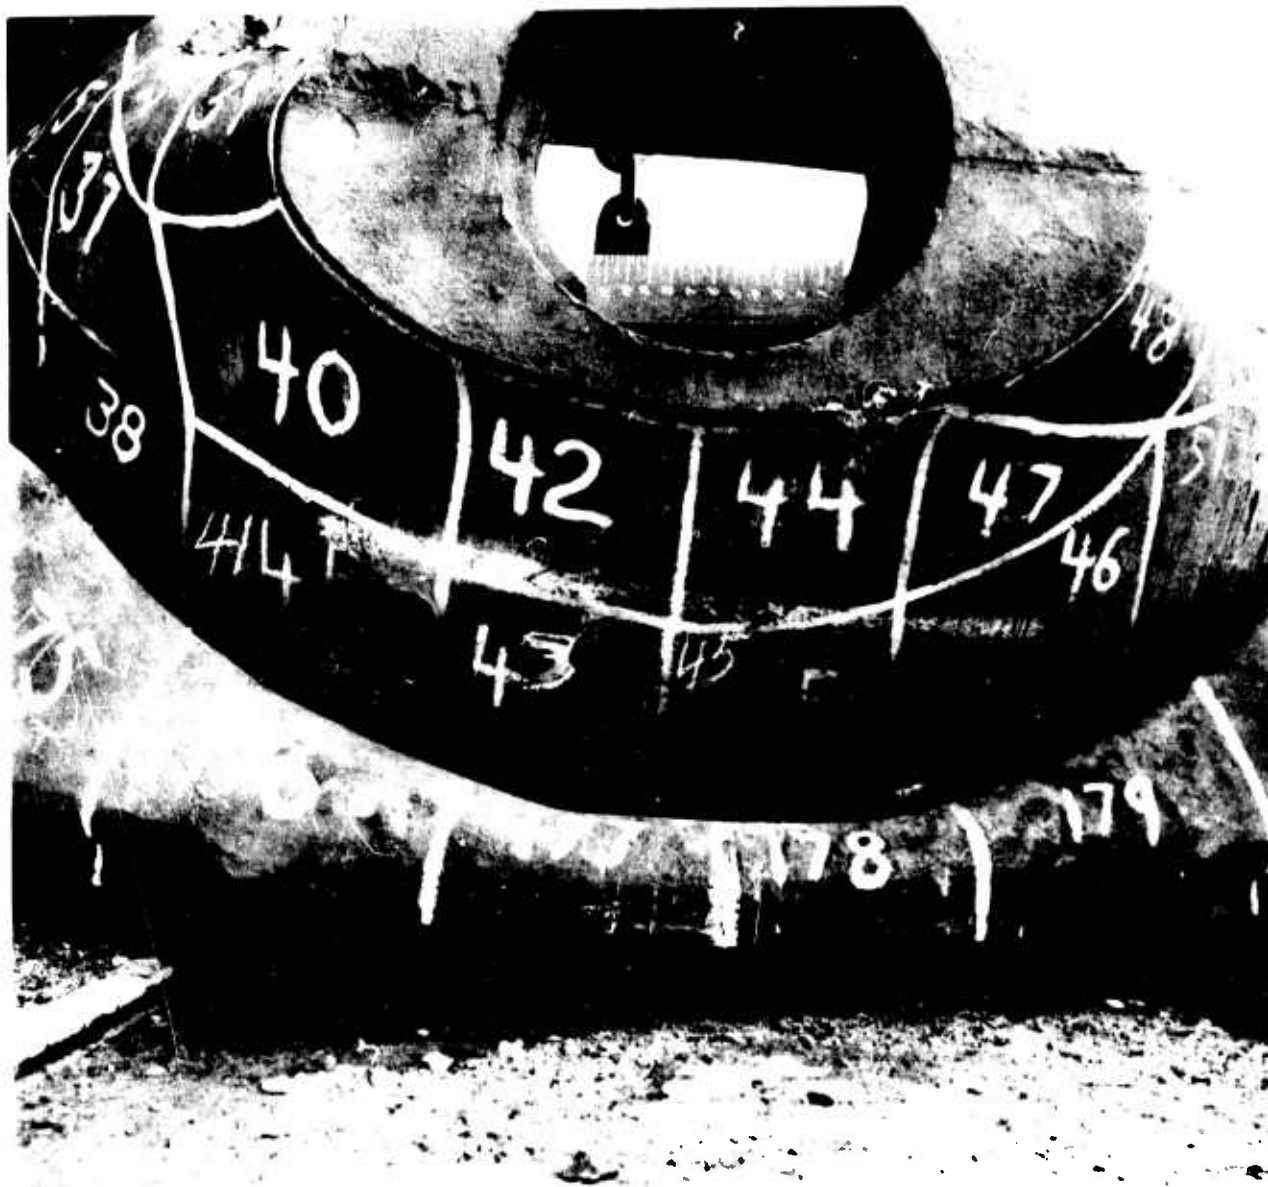
B18547: Effect of four 90mm AP T33 projectile impacts from direct front below the gun shield of the turret. Exterior view.

5. Each of the four rounds of 90mm AP T33E7 projectiles fired so as to impact in the area under the gun shield opening, with the turret in maximum elevation, resulted in complete immobilization of turret oscillation. Projectile fragments from the first round lodged between the turret body and skirting ring so tightly the body could not move. A drawbar strain gauge reading of 9375 lbs. was recorded but no movement of the turret was noted. The three remaining impacts resulted in face petalling extending over the skirting ring making it impossible to depress the turret before this petalling was removed with a cutting torch.
